# Retrieval findings of MoM hip prostheses

## Dr Tom Joyce Reader in Biotribology Newcastle University 24<sup>th</sup> October 2011

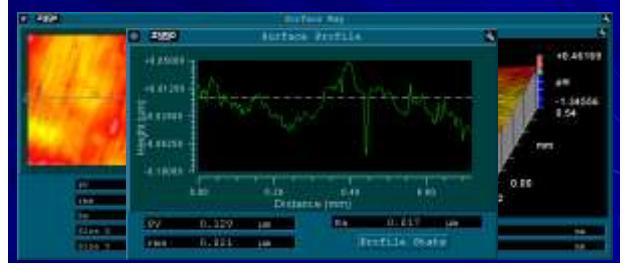
- ZYGO NewView non-contacting profilometer
- Typical changes 0.015µm to 0.100µm Ra
- Results in change from fluid film to boundary lubrication. Wear occurs over large sliding distance

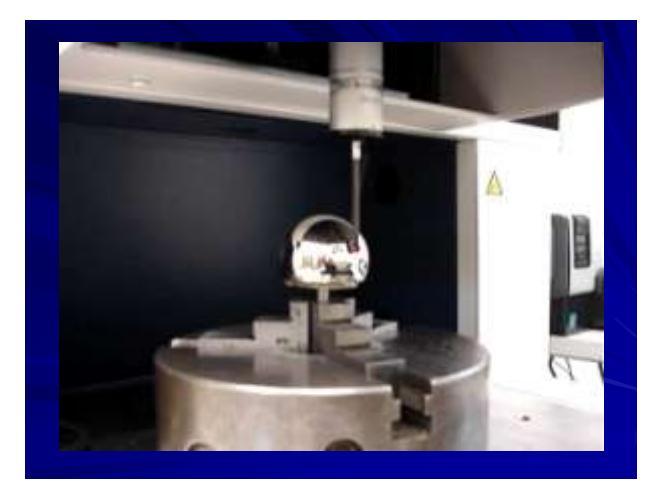
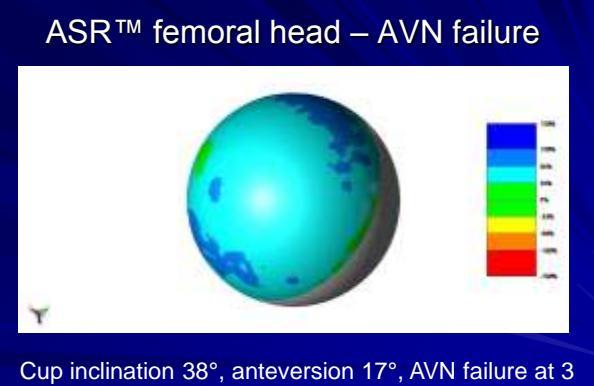
Cup inclination 38°, anteversion 17°, AVN failure at 3 years, total wear from head 1.3mm<sup>3</sup>

- Wear is a volume
- Co-ordinate Measuring Machine (CMM) recommended by international standards for measurement of wear in hip prostheses (ISO14242-2)
- State-of-the-art LEGEX 322 has an accuracy of 0.8µm

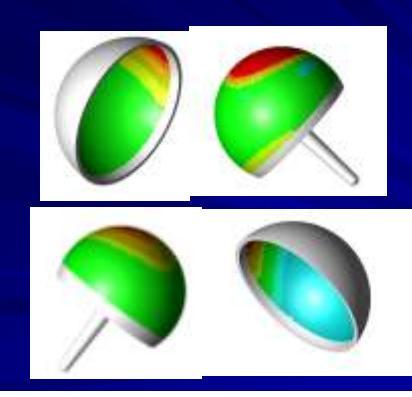
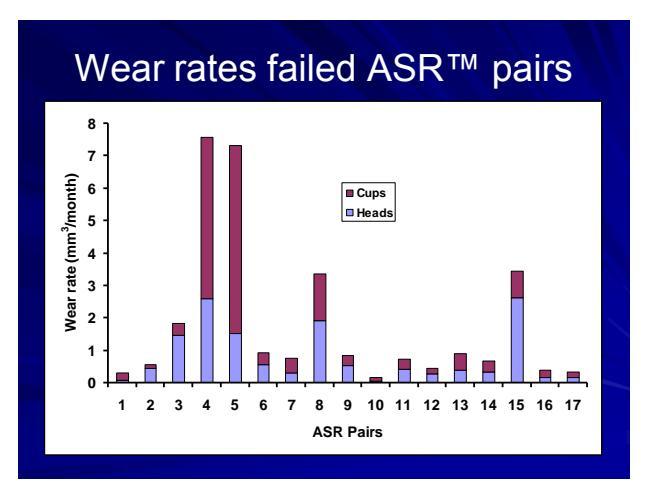
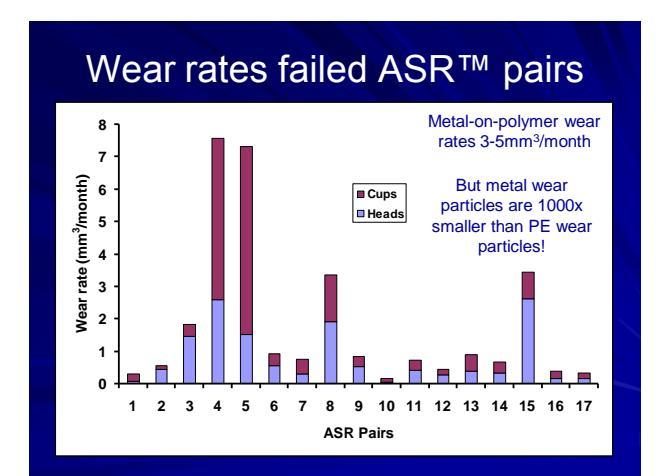
Common factor – 'rim wear' at edge of cup. Associated with smaller cups and those fitted at high inclination and/or anteversion angles

- Rim wear occurs on acetabular component
- High surface roughness values lead to shift from fluid film to boundary lubrication
- Wear volumes are high due to greater sliding distance in large diameter resurfacing designs
- Wear volumes correlate with high Co and Cr ion concentrations in blood of patients
- Tissue destruction and pain linked with metal wear debris

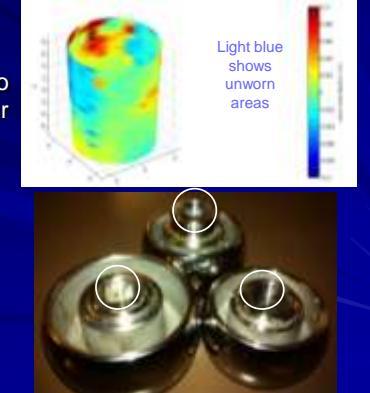
- Wear at the taper junction
- We use our CMM to measure taper wear
- Example 0.7mm<sup>3</sup> taper volume loss; maximum wear depth 39 microns
- Enough to cause failure and tissue destruction in this patient

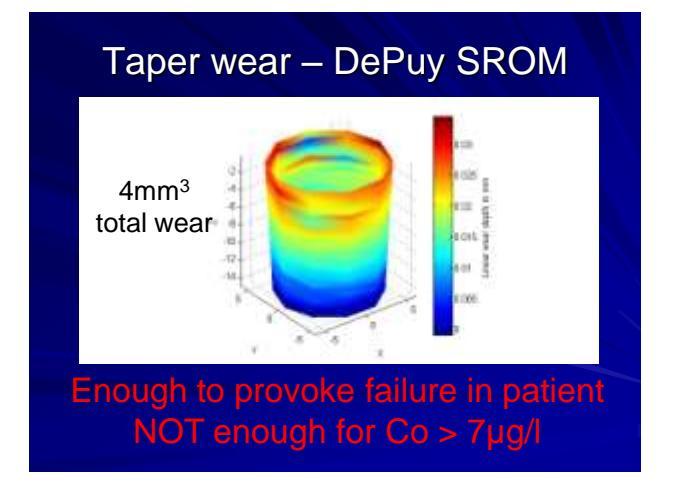
Maximum wear depth 22 microns

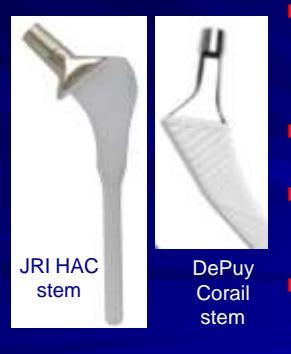
- These materials (CoCr and Ti) have been used together for many years in this application
- Why would corrosion suddenly be a problem?
- Stems have become smaller as heads have become bigger
- Localised damage consistent with increased lever arm
